# Evidence of ineffective cleaning and disinfection procedures in pig transport

Laura Courtens, Evelien Biebaut, Ilias Chantziaras, Filip Van Immerseel, Jeroen Dewulf  
Faculty of Veterinary Medicine, Ghent University, Belgium

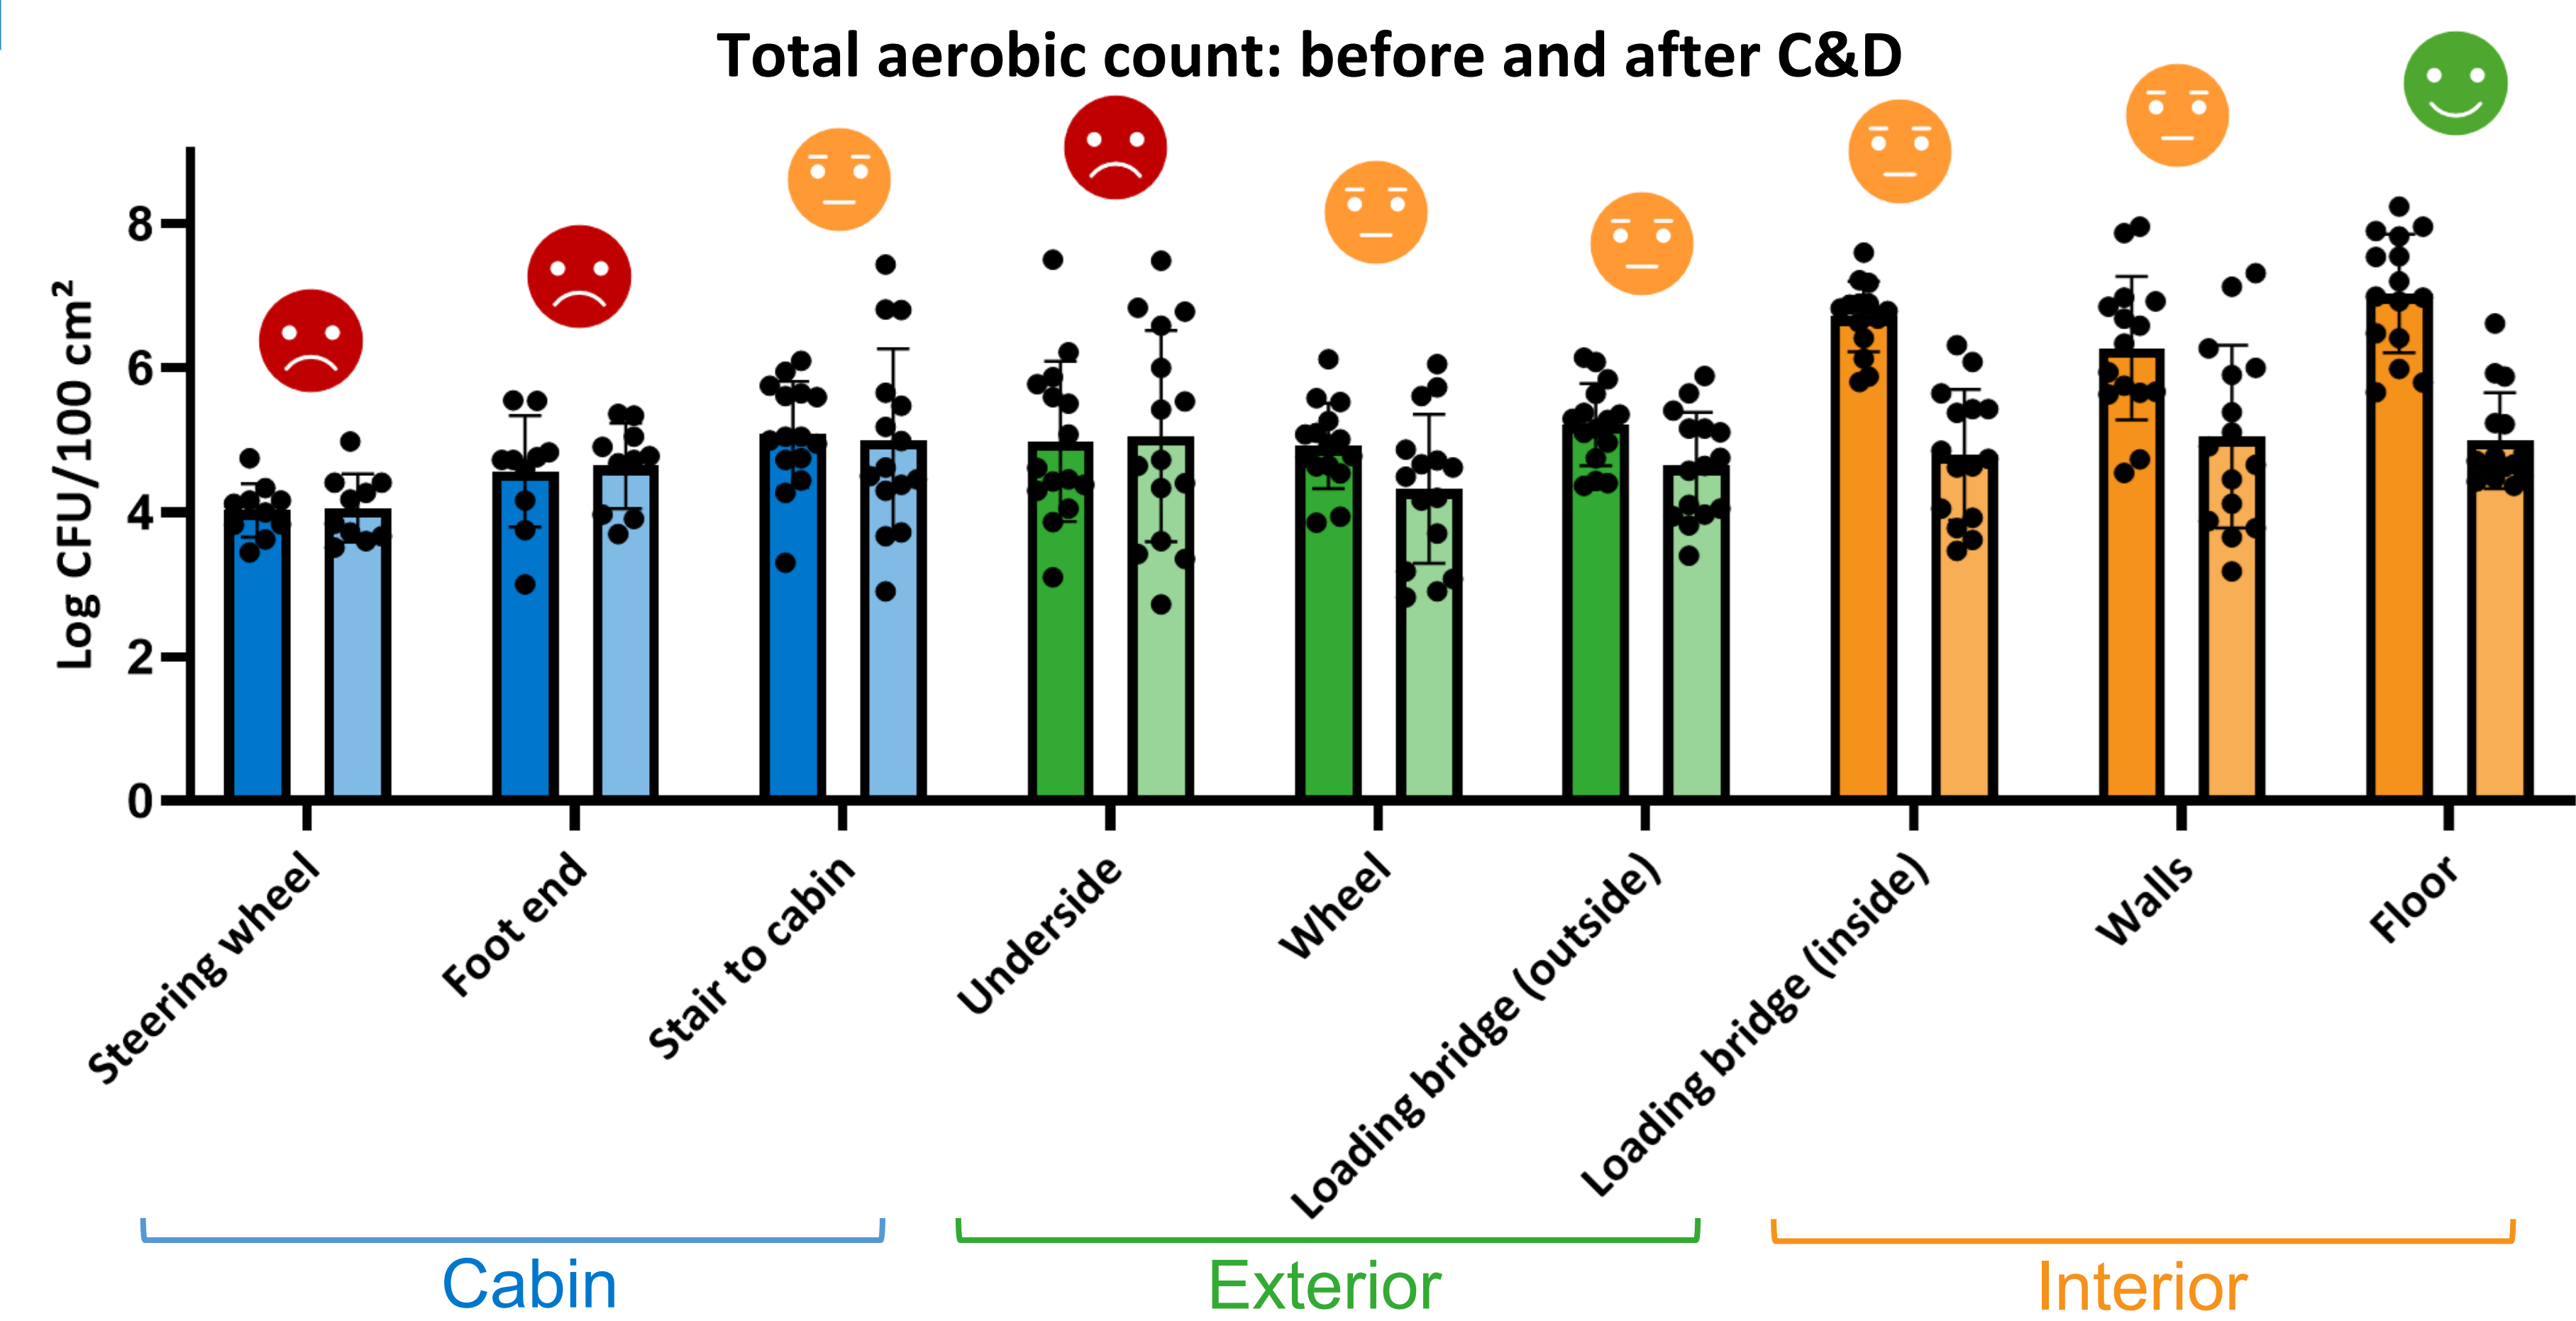
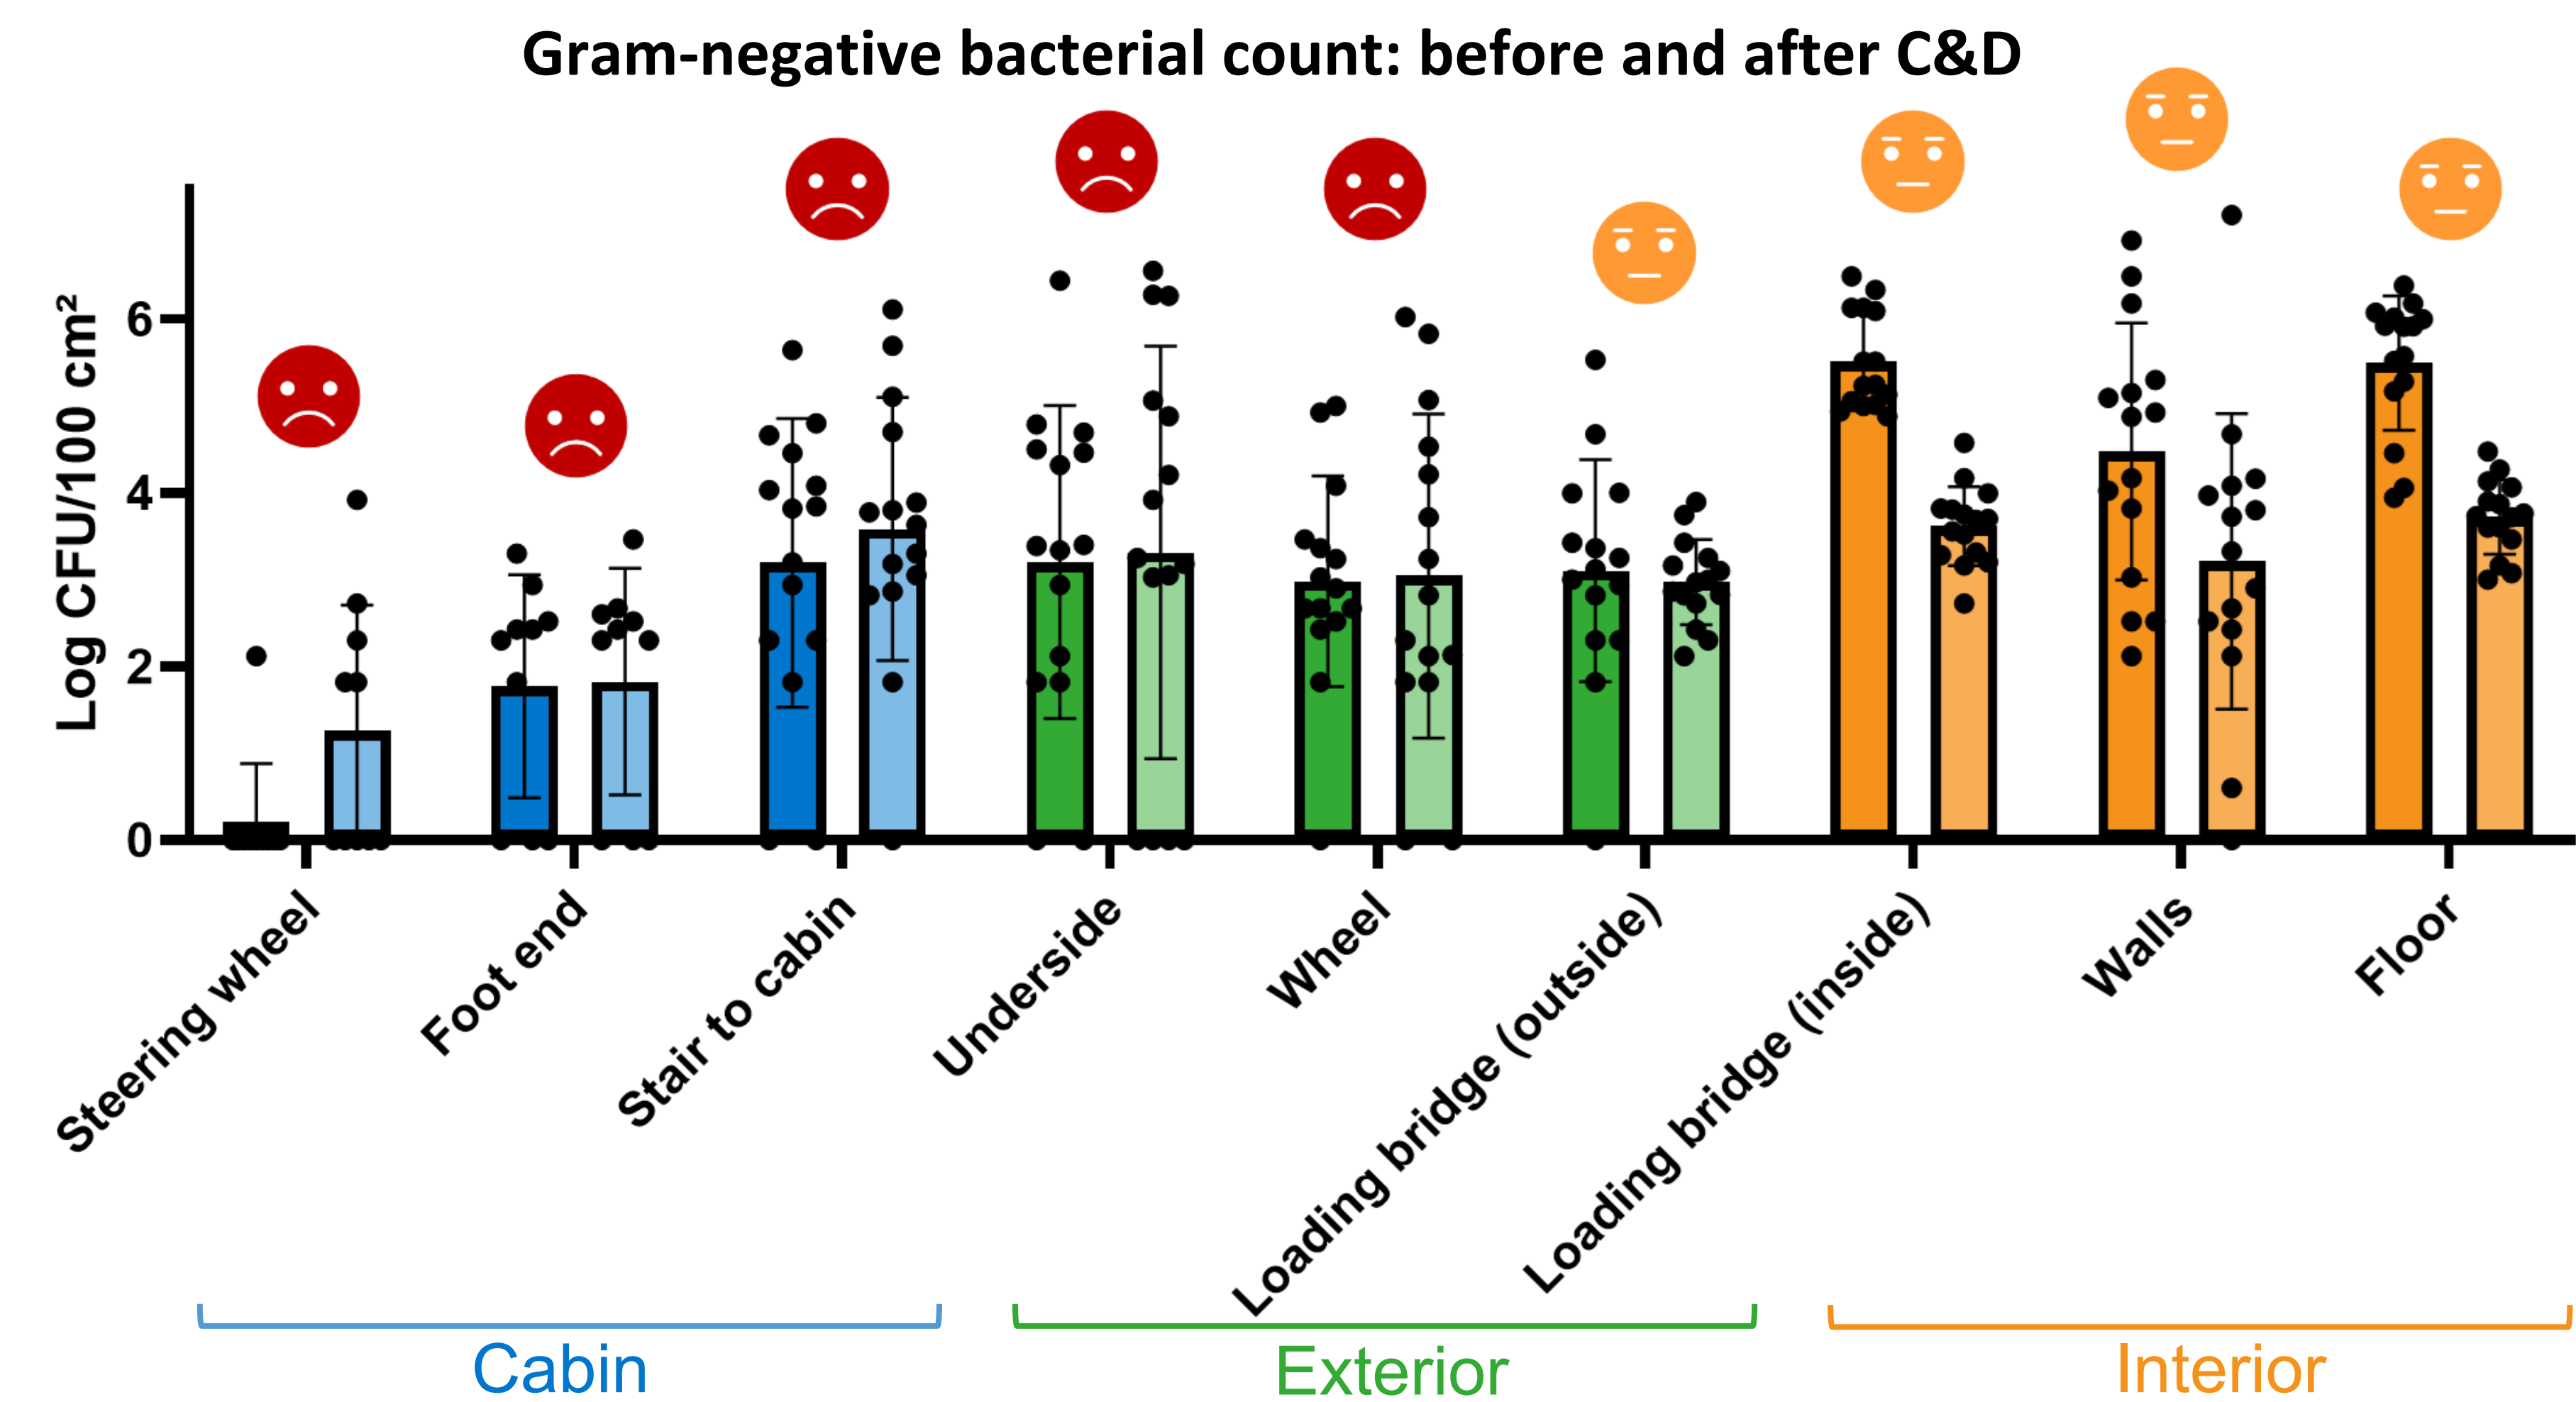
- Aerobic bacteria levels** decreased in most areas after C&D, except the steering wheel, foot end, and underside; only the floor met acceptable reduction standards.
- Despite C&D, all sampled areas still contained **gram-negative bacteria**.
- Nearly all dominant bacterial genera (19 out of 20) originate from the **porcine gut**.

- C&D showed **limited reduction of bacterial load**. Some locations had increased contamination after C&D.
- All sampled locations remain **fecally contaminated** when leaving the slaughterhouse.
- Current practices are **inadequate** to prevent transmission via pig transport vehicles.

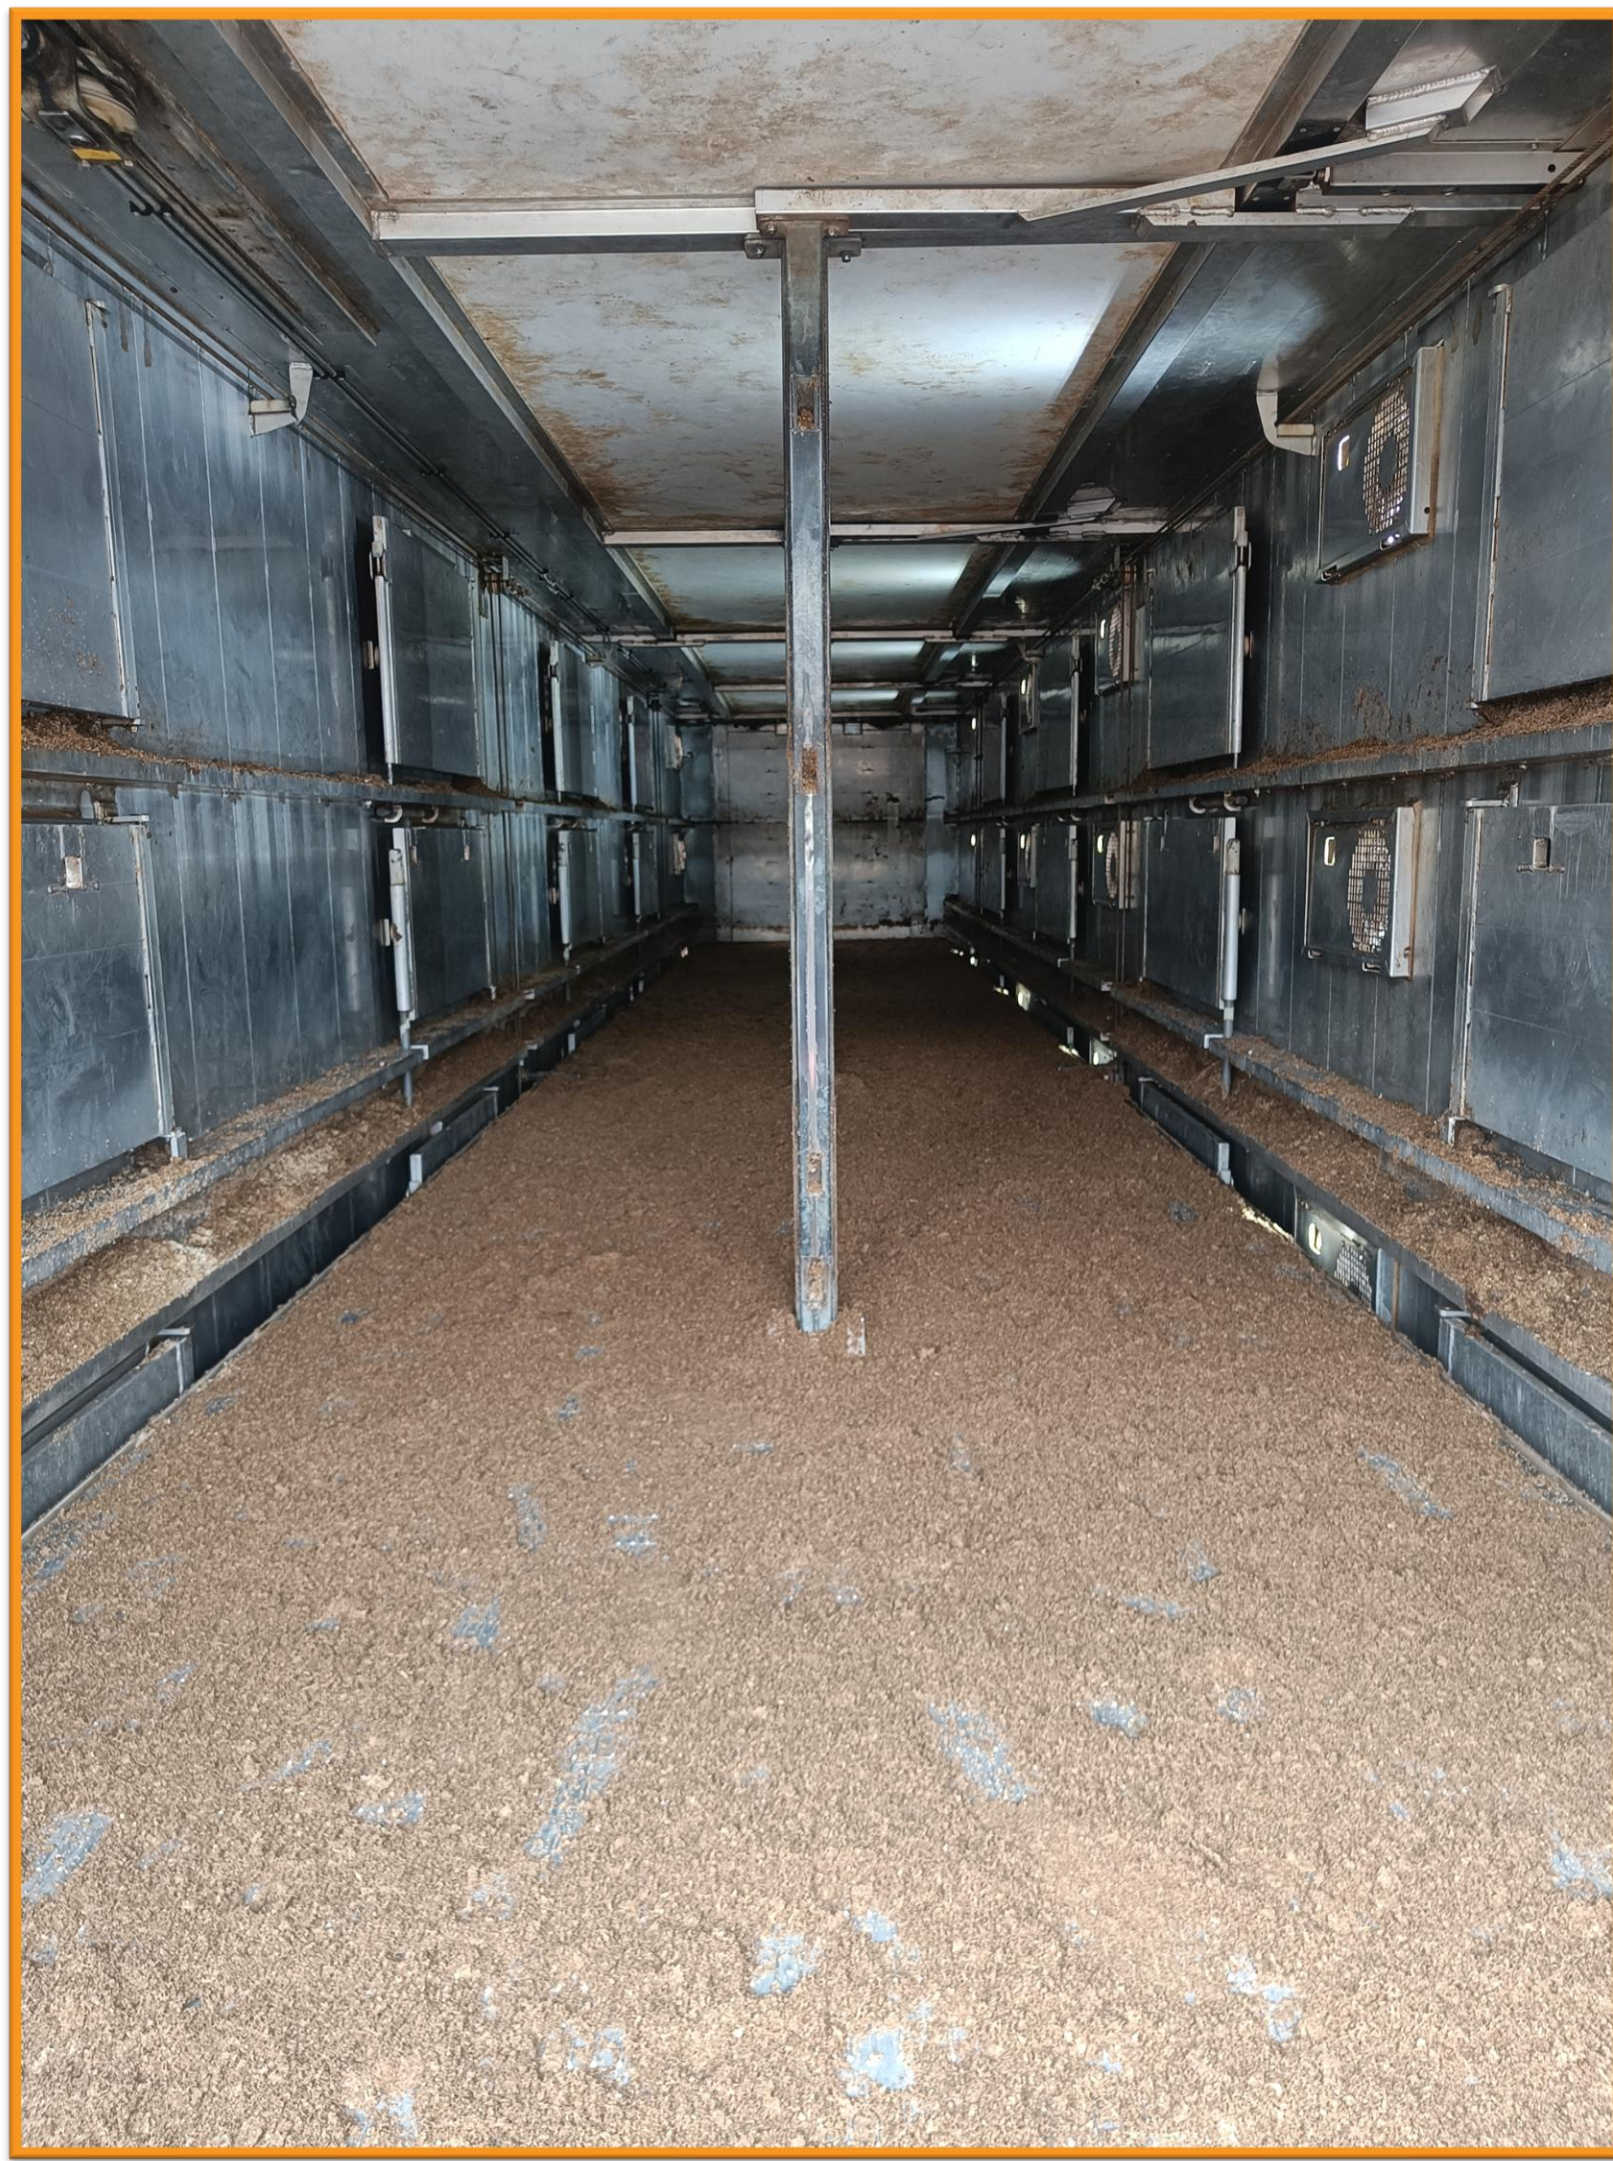
Interior of trailer: before cleaning

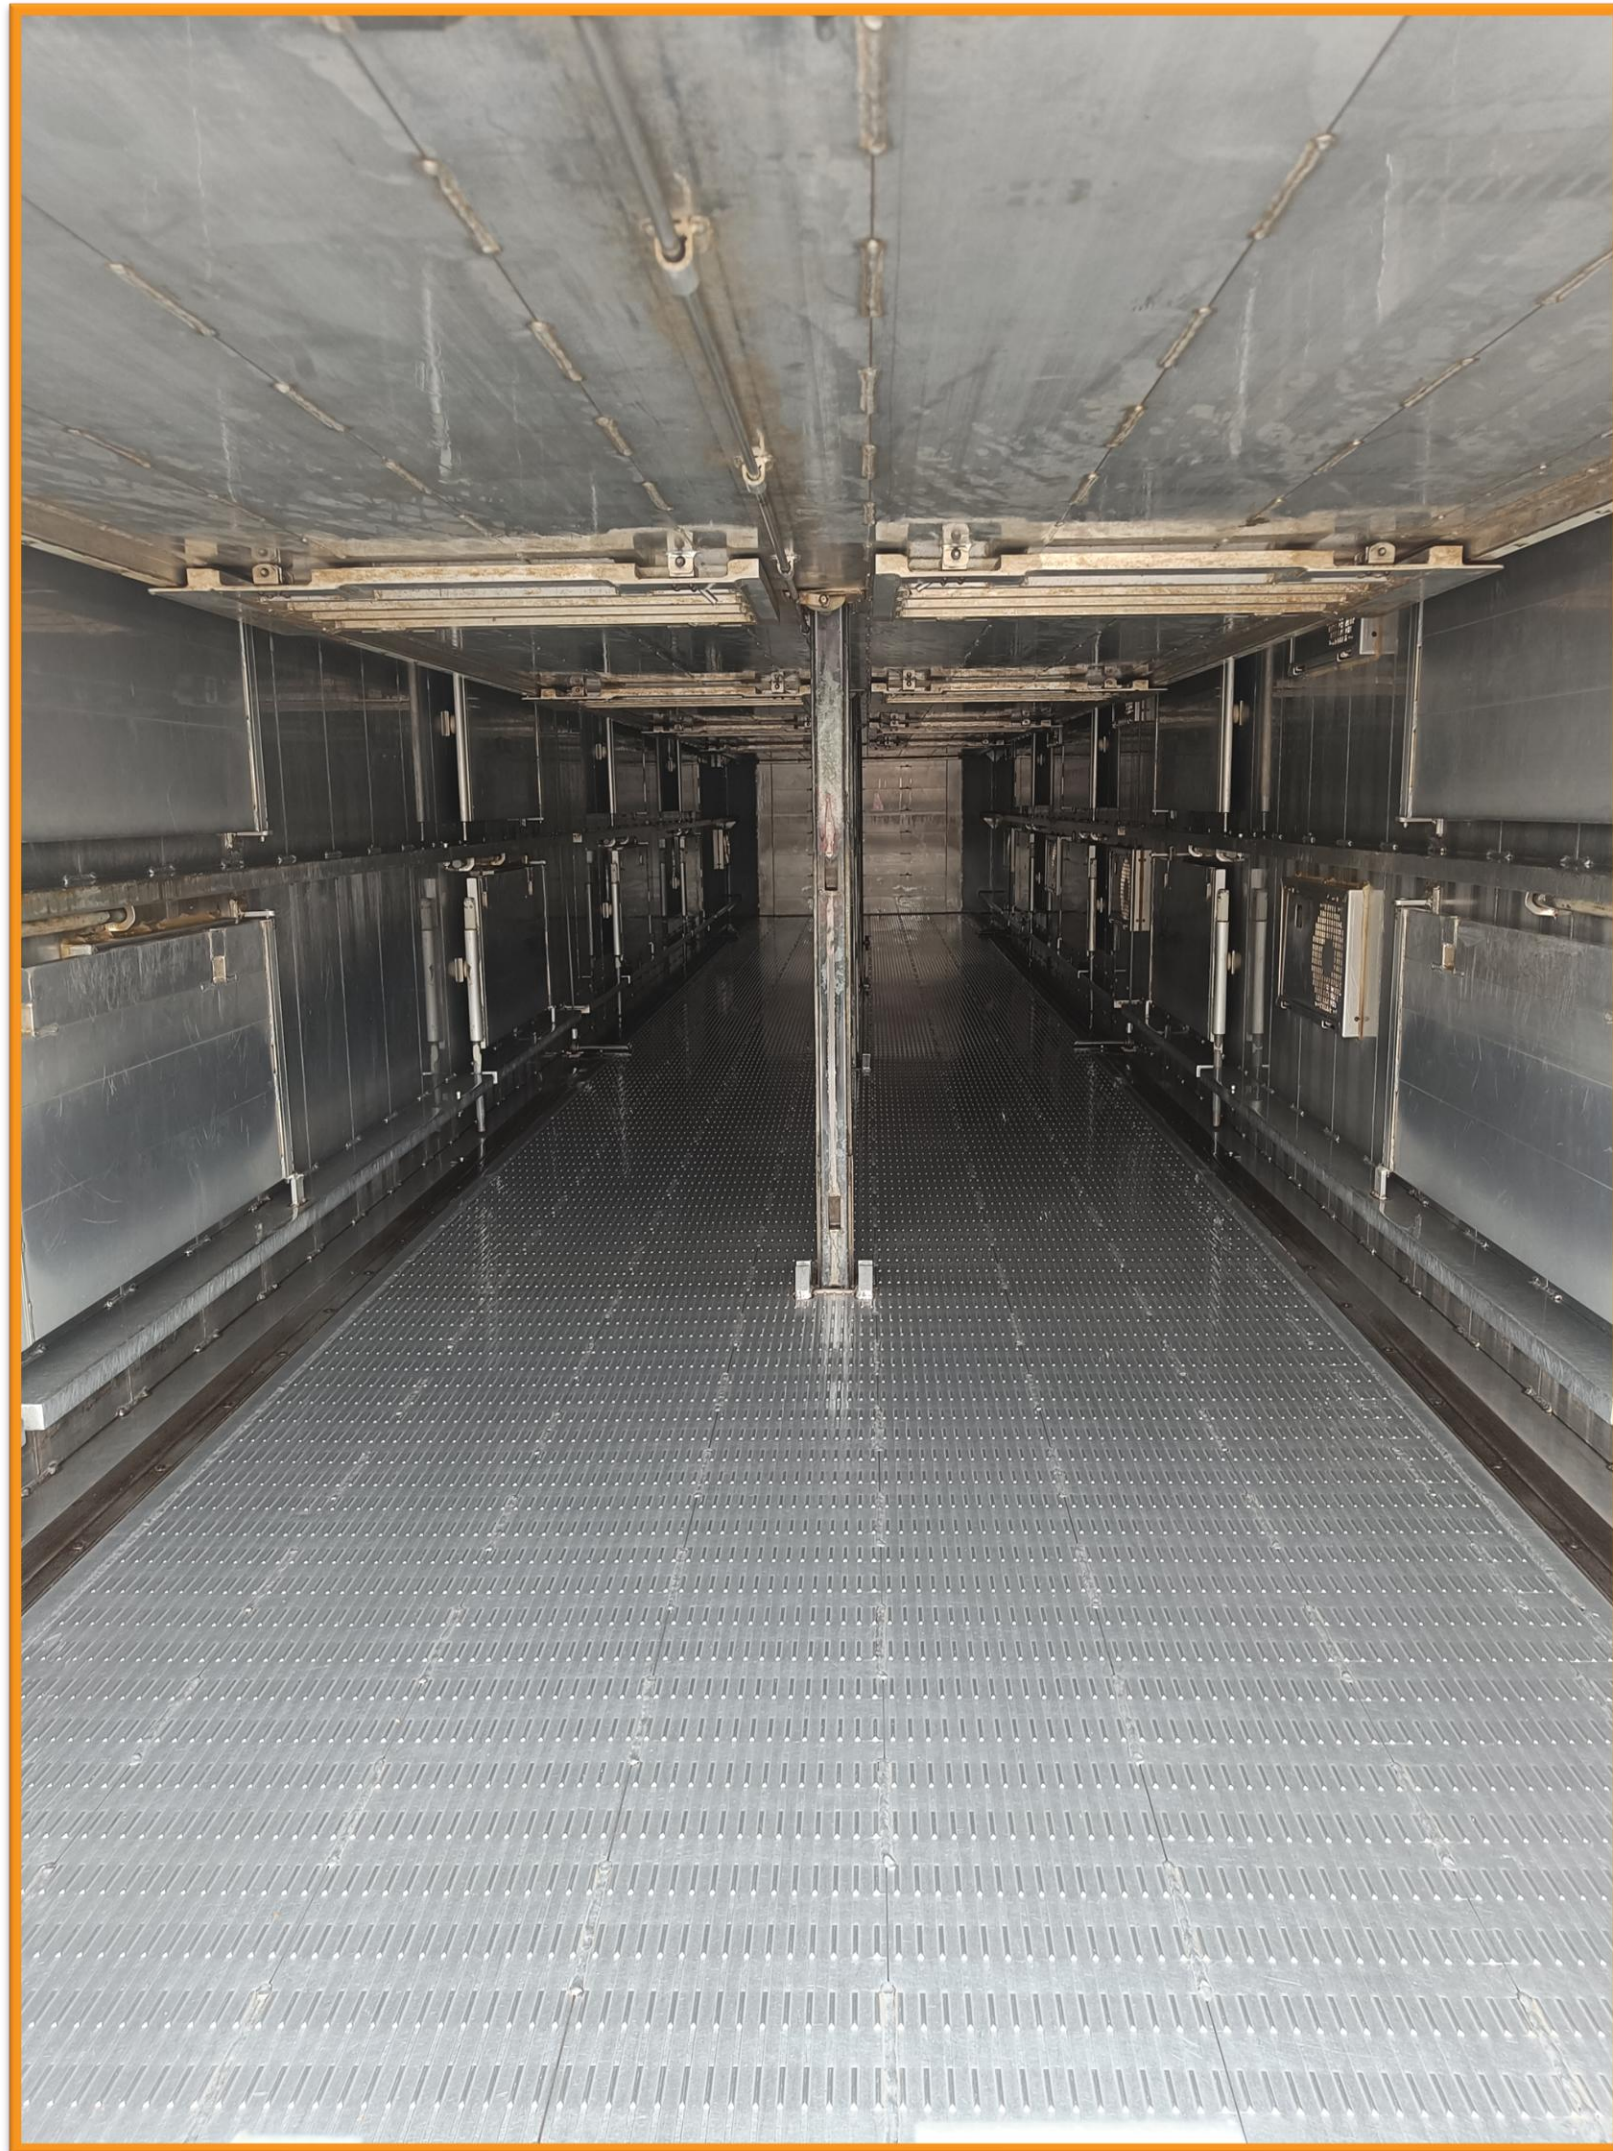
Interior of trailer: after disinfection

Trailer of the trucks were cleaned and disinfected until visually clean.
